RGS/PUMP MOTOR SWITCH FAILURE AND REPLACEMENT

Revised 9/5/2013

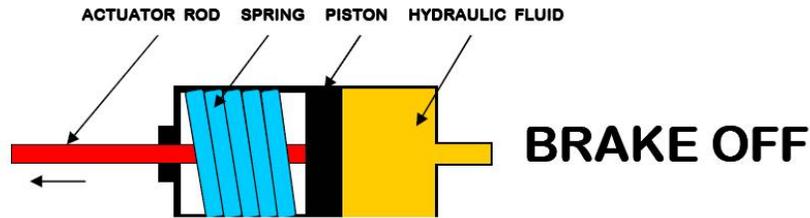
AUTOPARK ACTUATOR

This drawing depicts the AutoPark actuator with hydraulic pressure applied. In this condition, the brake is **RELEASED**. The piston is forced to the left by the hydraulic fluid, and the actuator rod has relaxed the tension on the cable to the brake assembly.

The actuator is the heart of the AutoPark system. It is a hydraulic cylinder which applies or releases a drum brake on the driveline. It is also important to remember that hydraulic pressure **RELEASES** the brake, and that lack of pressure **APPLIES** the brake. As such, **BRAKE APPLIED** is the default condition for most malfunctions of the AutoPark system.

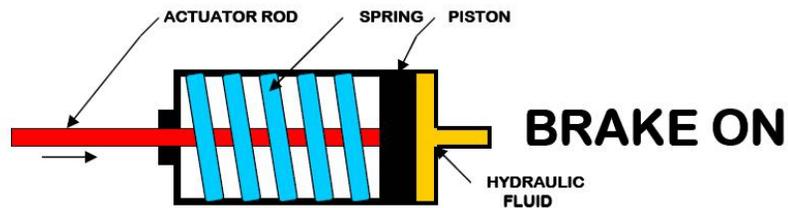
This drawing depicts the AutoPark actuator with no hydraulic pressure on it. In this condition, the brake is **APPLIED**. The piston is forced to the right by the heavy spring, and the actuator rod is putting tension on a cable connected to the brake assembly.

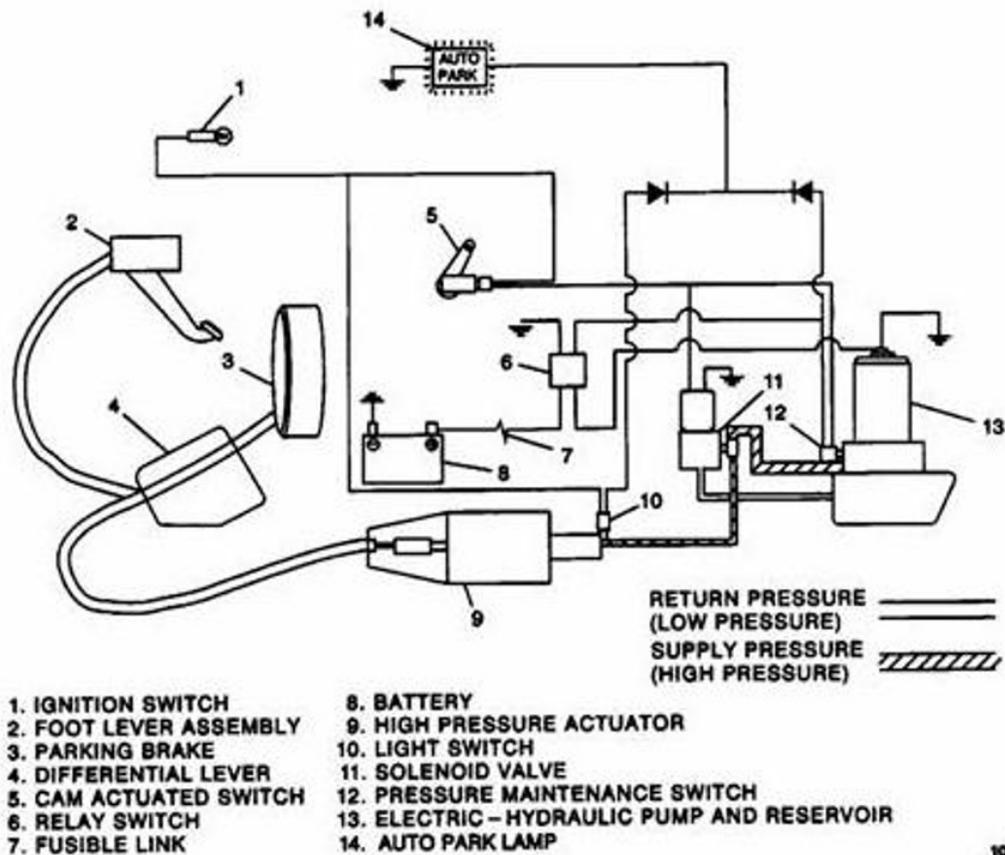
10-00-3206T1

This is what we call Version II of the AutoPark system. The parking brake with this configuration may be applied by putting the gear shift lever in PARK, or by depressing the manual foot pedal #2.

to the actuator. It is designed to turn on the pump at pressures below 1200 psi, and turn the pump off when the pressure reaches 1600 psi.

This switch typically fails in two stages. In the first stage, oil under high pressure from the pump, gets inside the switch and causes the switch to lock in the ON position. With the switch staying ON, the system pressure then goes sky high. The very high pressure at some point ruptures the switch, and oil starts trickling out past the switch terminals. Eventually, all the oil will leak out and the actuator will apply the parking brake for lack of hydraulic pressure.

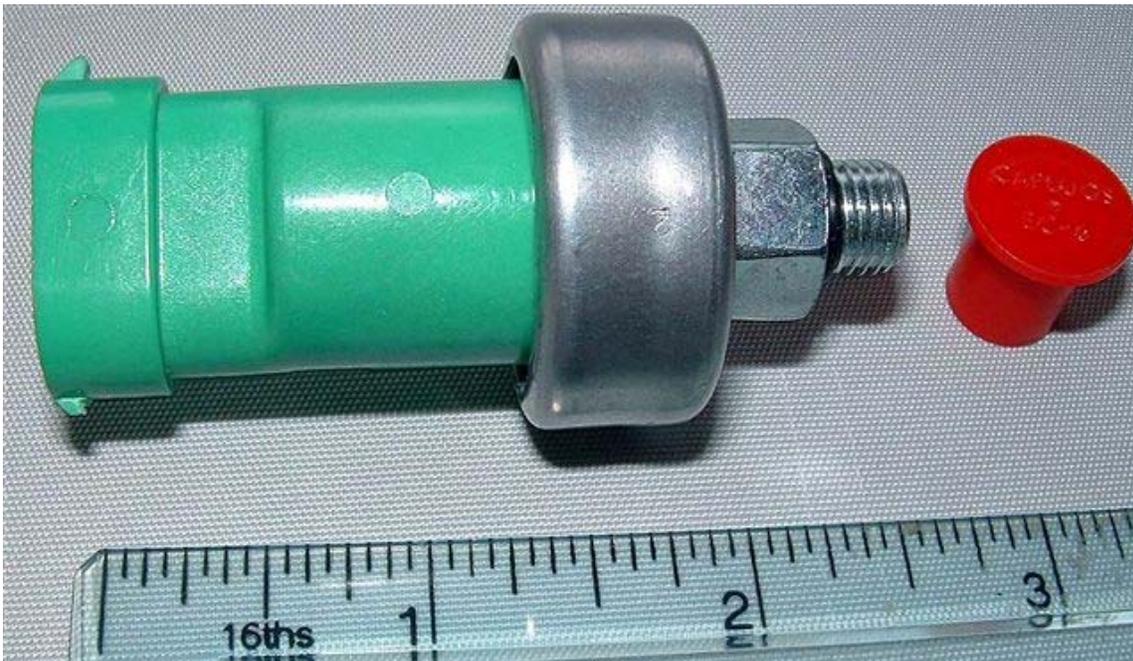
Below is a picture of a new Rotten Green Switch - - as mentioned elsewhere, it is sometimes brown in color, but the function is unchanged regardless of whether it is brown or green.

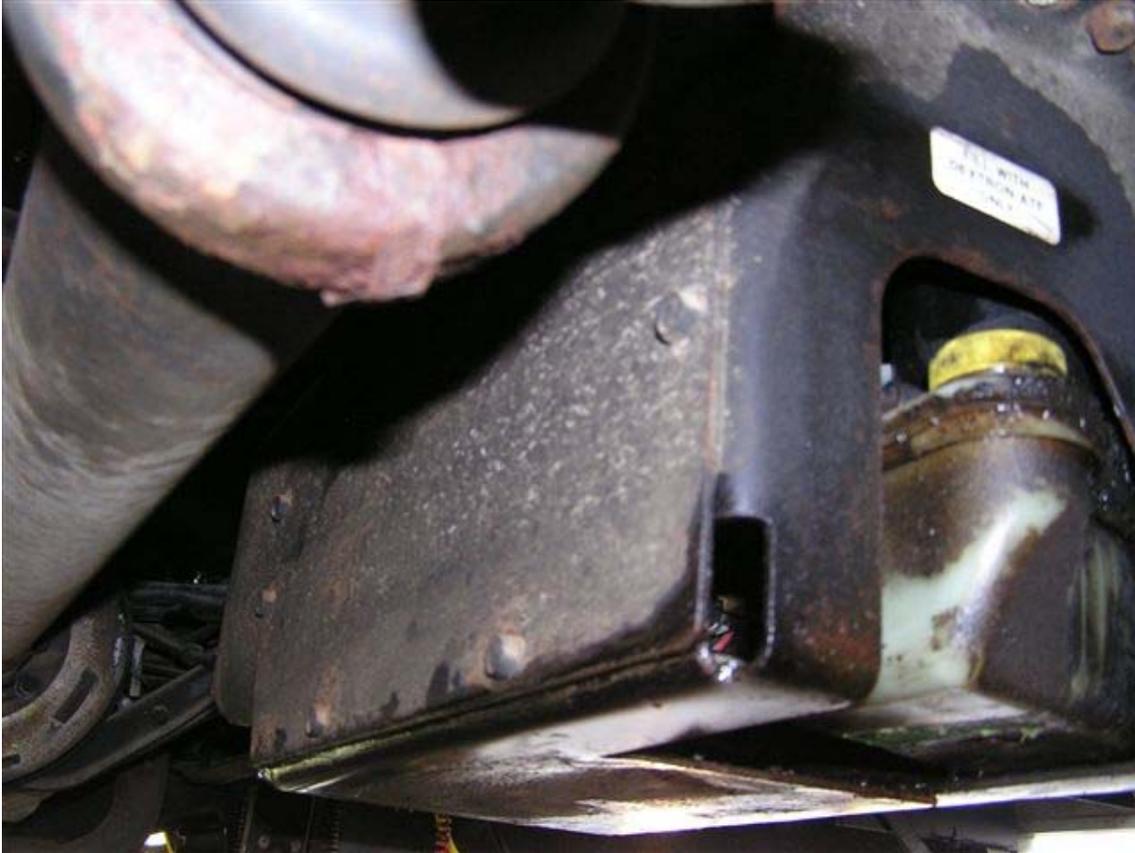
Chock your wheels - - you'll be getting under the rig unless it is a 2001 or later in which case the pump/reservoir and RGS are up in the front of the coach - - driver's side by the radiator. On earlier models, look on the passenger side of the transmission next to the frame rail, but slightly aft of the tranny itself. You should see the reservoir easily, but will probably have to remove a sheet metal plate to see the AutoPark mechanism and the RGS. It looks like this:

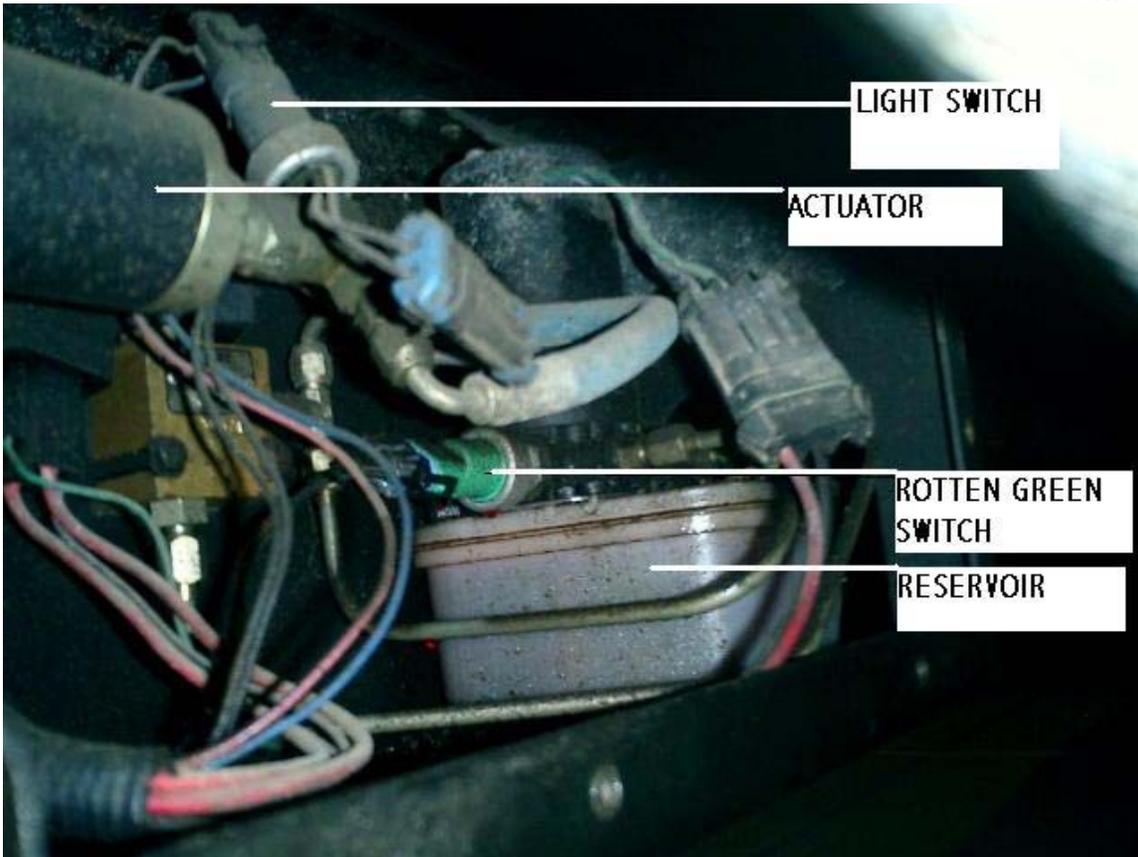
With the lid removed, the Goodie Box will look much like this inside:

This particular picture is of a 95 version. The newer units have a plastic reservoir but the general layout is much the same.

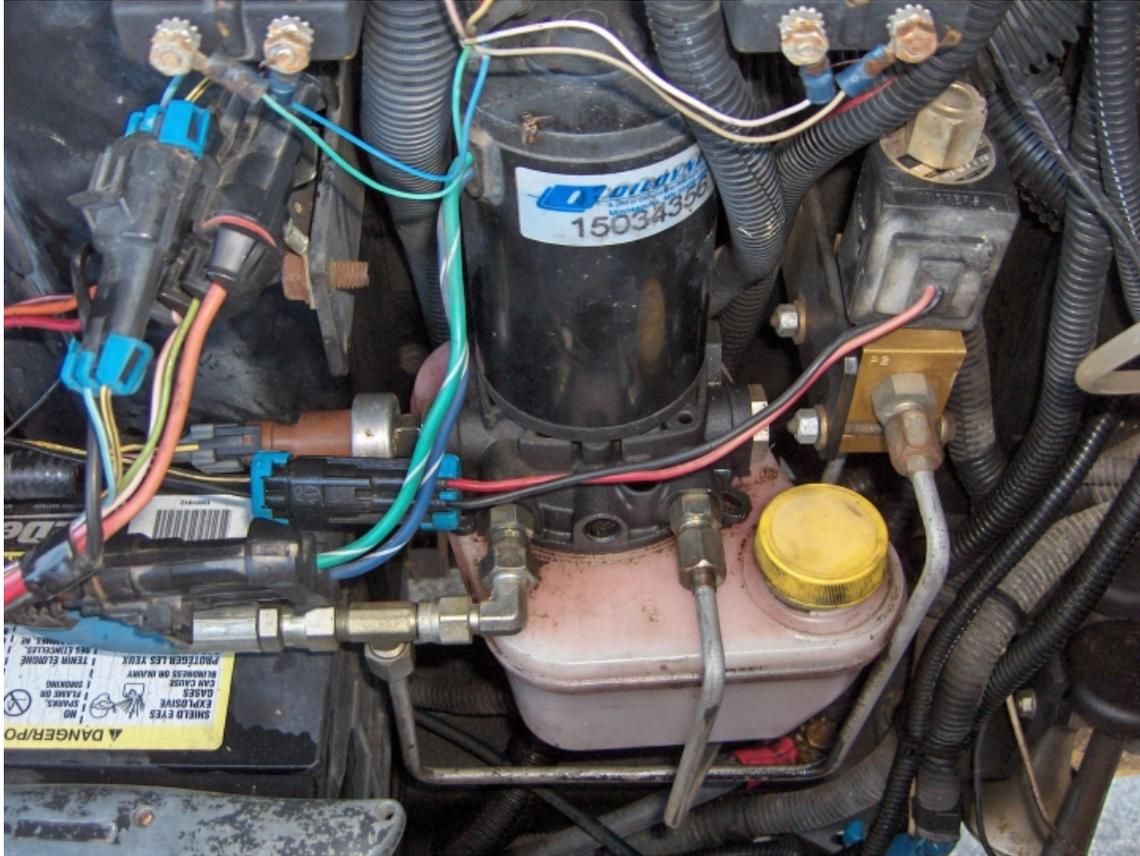
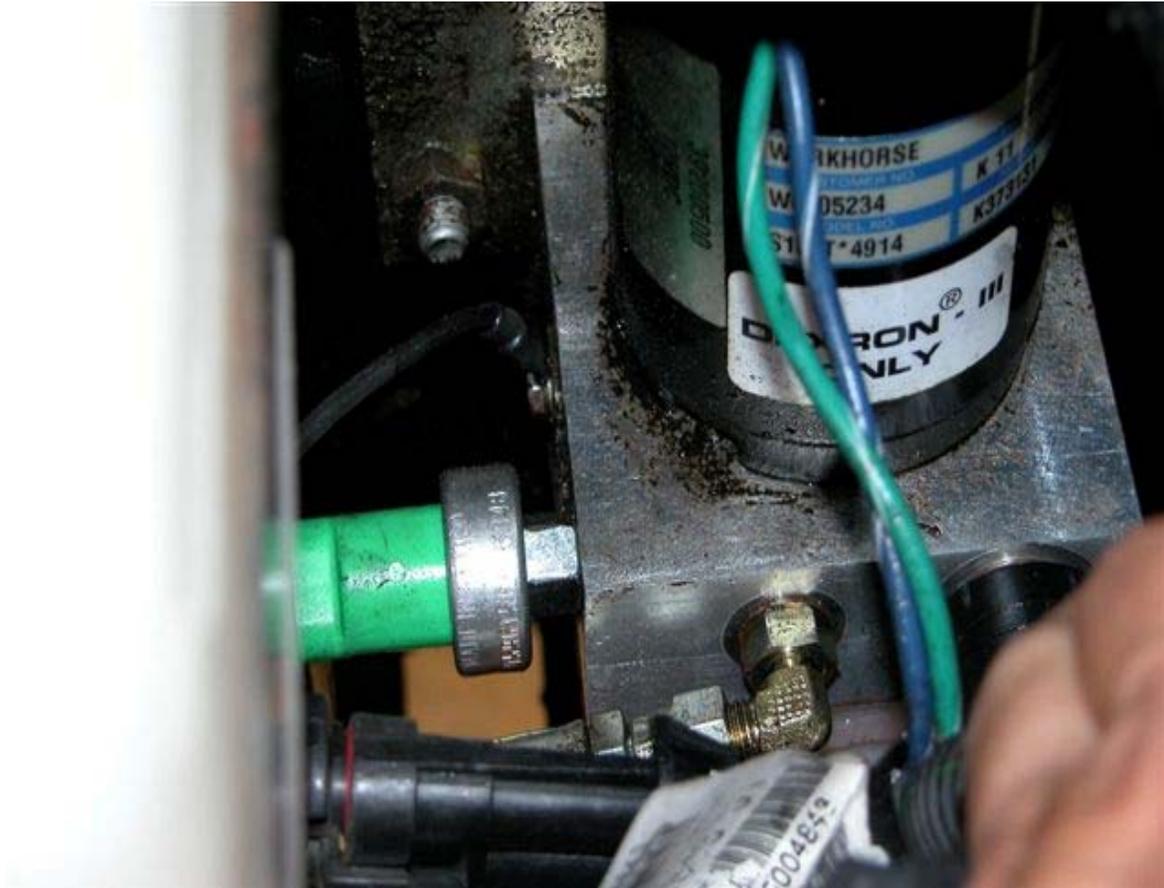
If you have the later version with the pump located up front under the utility hood to the driver's side of the radiator, it will look more like this:

Notice that the newer version (of the Parker pump) has a Rotten Brown Switch instead of a Rotten Green Switch. If your pump does NOT look like the first picture, you may have the Pump/motor that is made by MTE - - (above picture). Both the Oildyne and the MTE perform the same functions.

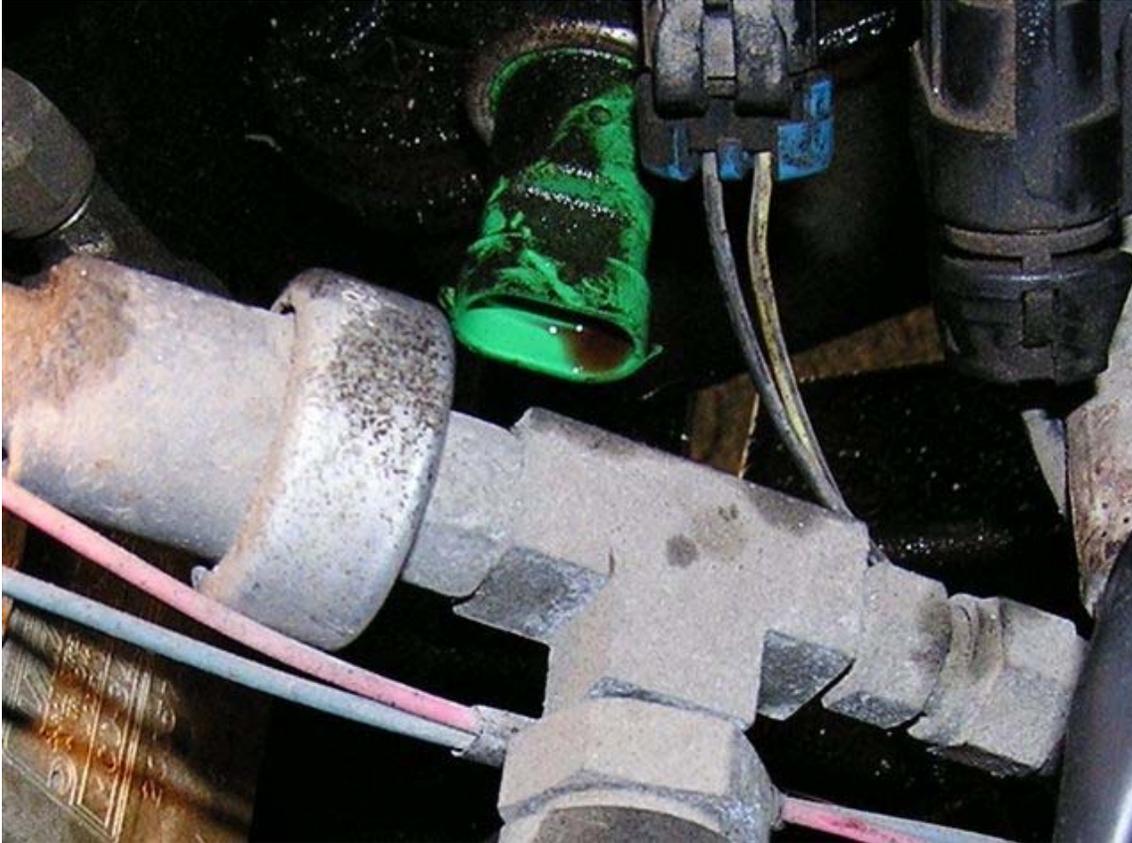
Here is a picture of a leaking/oily RGS:

Even if the RGS is NOT OILY, you will still want to remove the electrical connector from it. If AutoPark lite GOES OFF after disconnecting the plug on the RGS (ignition still ON), then you have confirmed that the RGS is bad.

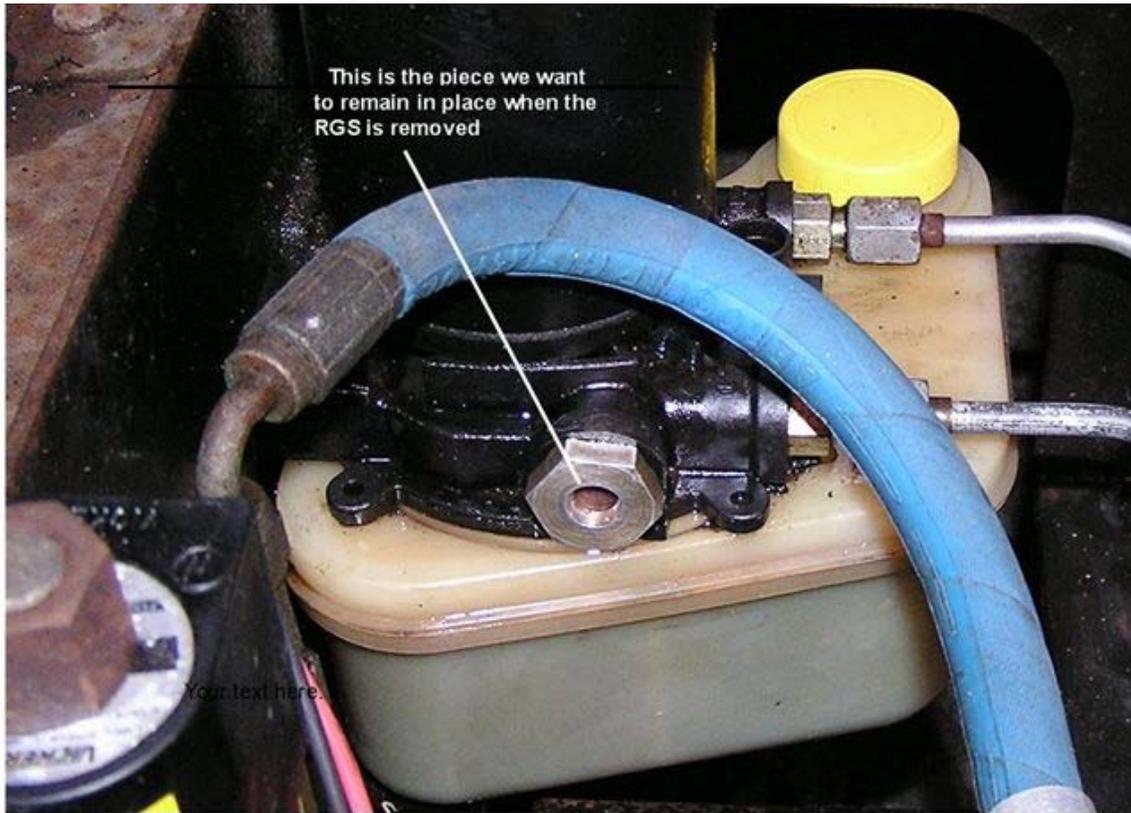
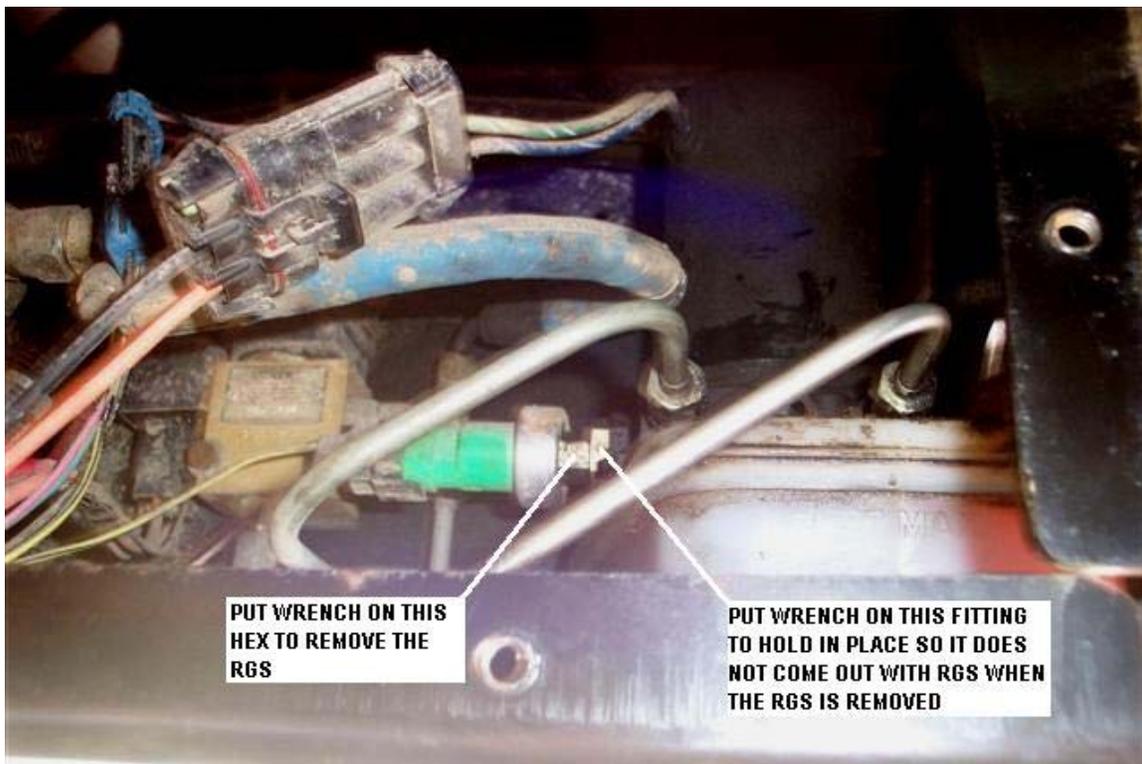
We have attached a pair of pictures on the following page that help to explain the above problem. In the picture below, it is important to note that the shiny hex adapter is made of very soft material, and it is pretty easy to strip the threads by over tightening the RGS when threading it into the adapter.

This picture shows the RGS installed - - screwed into the hex adapter which in turn is screwed into the pump base.

The RGS threads into a piece that looks somewhat like a hex pipe reducer. It is made of shiny soft aluminum. One side of this reducer has a 3/8 - 24 female thread into which the RGS screws. The other (male) end screws into the pump body itself. Several people have said that they stripped the female thread in the process of installing the new RGS, and have thus found it

There is another *potential problem* in installation of the RGS. The adapter, described above as looking somewhat like a pipe reducer, retains a very important spring and poppet valve. If the adapter/reducer is taken out along with the RGS, it is *really easy* to lose the spring without even knowing it. Without the spring, the poppet will oscillate rapidly back and forth - - producing a rapid chattering of the pump, and a fast blinking AutoPark lite.

Consequently, *anyone replacing an RGS should be aware of the potential problems*. For whatever reason this hex valve fitting may be removed, the mechanic must be careful not to lose any of the parts of the poppet assembly. We do have an annotated picture of the system that shows and labels the RGS and the hex reducer. We also have (courtesy of the pump manufacturer), exploded views of the poppet assembly and corresponding part numbers, just in case someone should lose any of these pieces. The obvious way to avoid these miseries is to remove **ONLY** the RGS and **NOT** the hex reducer which retains the poppet assembly.
